Curley Creek Watershed Assessment and Protection and Restoration Plan

November 27, 2017
FINAL REPORT

**THE
SUQUAMISH
TRIBE**

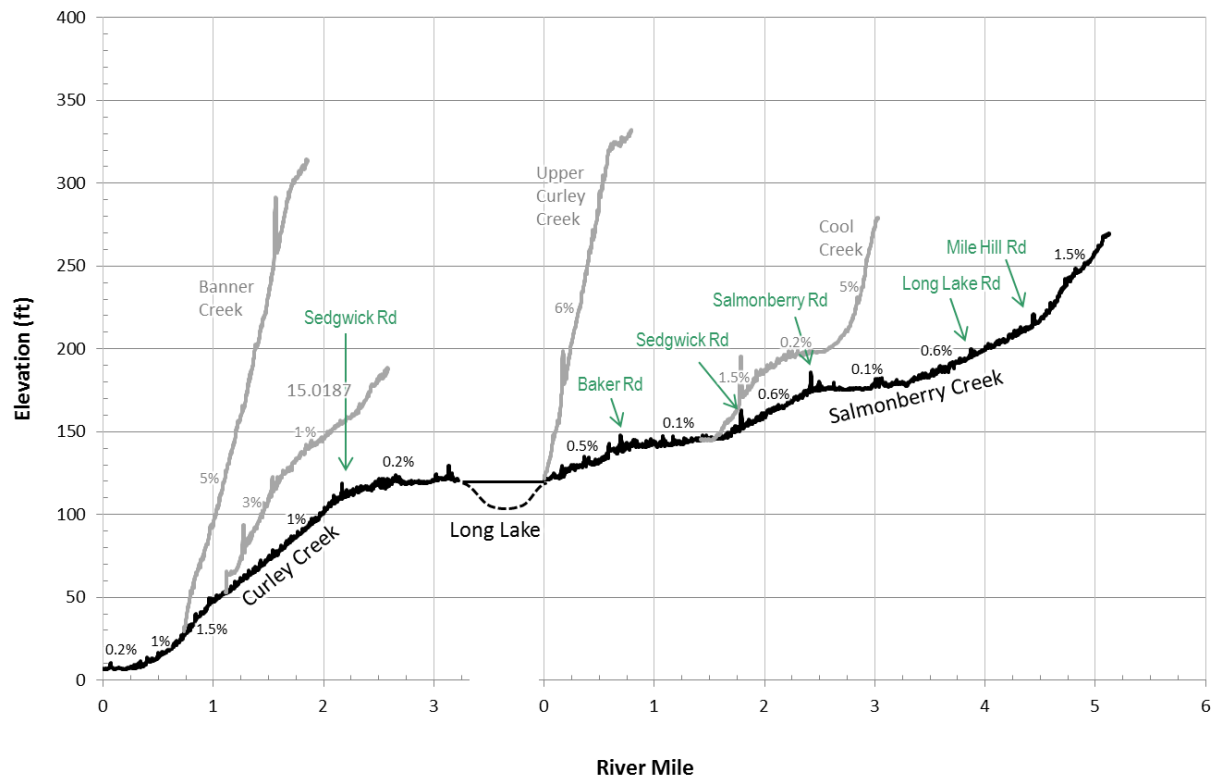
Figure 1-2. Longitudinal profile of Curley Creek and key tributary channels derived from lidar DEM.

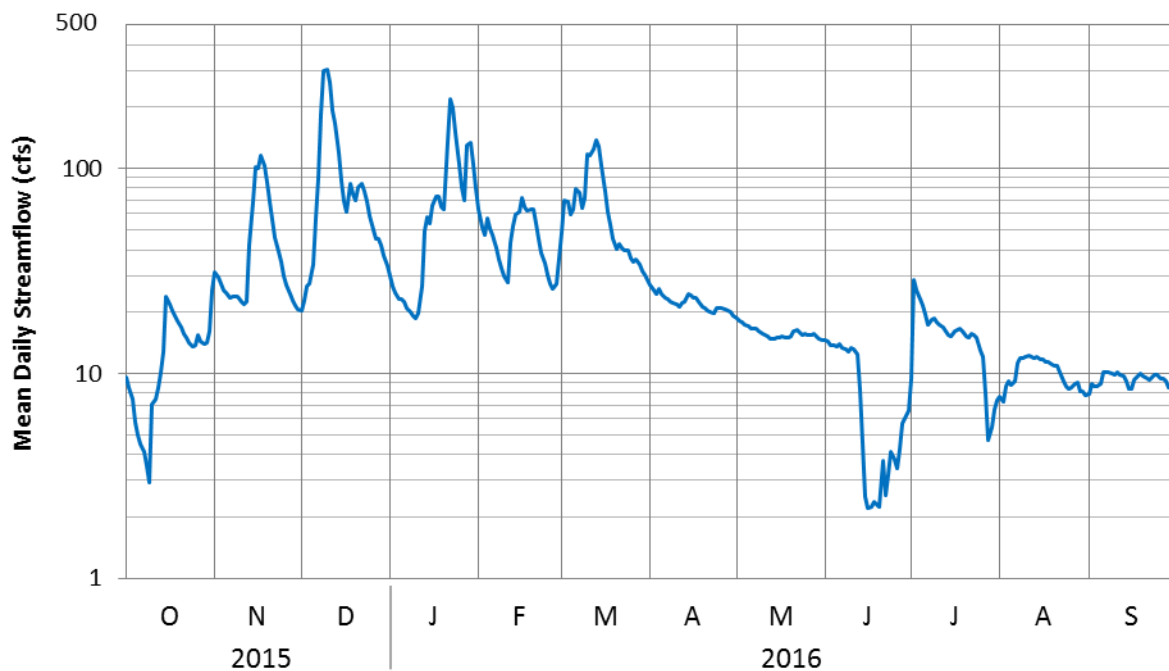
Figure 3-1. Annual hydrograph for water year 2016 with mean daily flow in Curley Creek near Sedgwick Road (Kitsap Public Utility District).

The only segment of the watershed that can be evaluated based on streamflow metrics is Curley Creek downstream of the lake given the lack of streamflow data representing other parts of the watershed, in particular Salmonberry Creek. Even Curley Creek cannot be evaluated with data representing unaltered conditions given the short period of record. We have classified high flow, low flow and variability indicators as “Fair” in Curley Creek based on knowledge of watershed conditions and past impacts to floodplain processes that are important for attenuating flows.

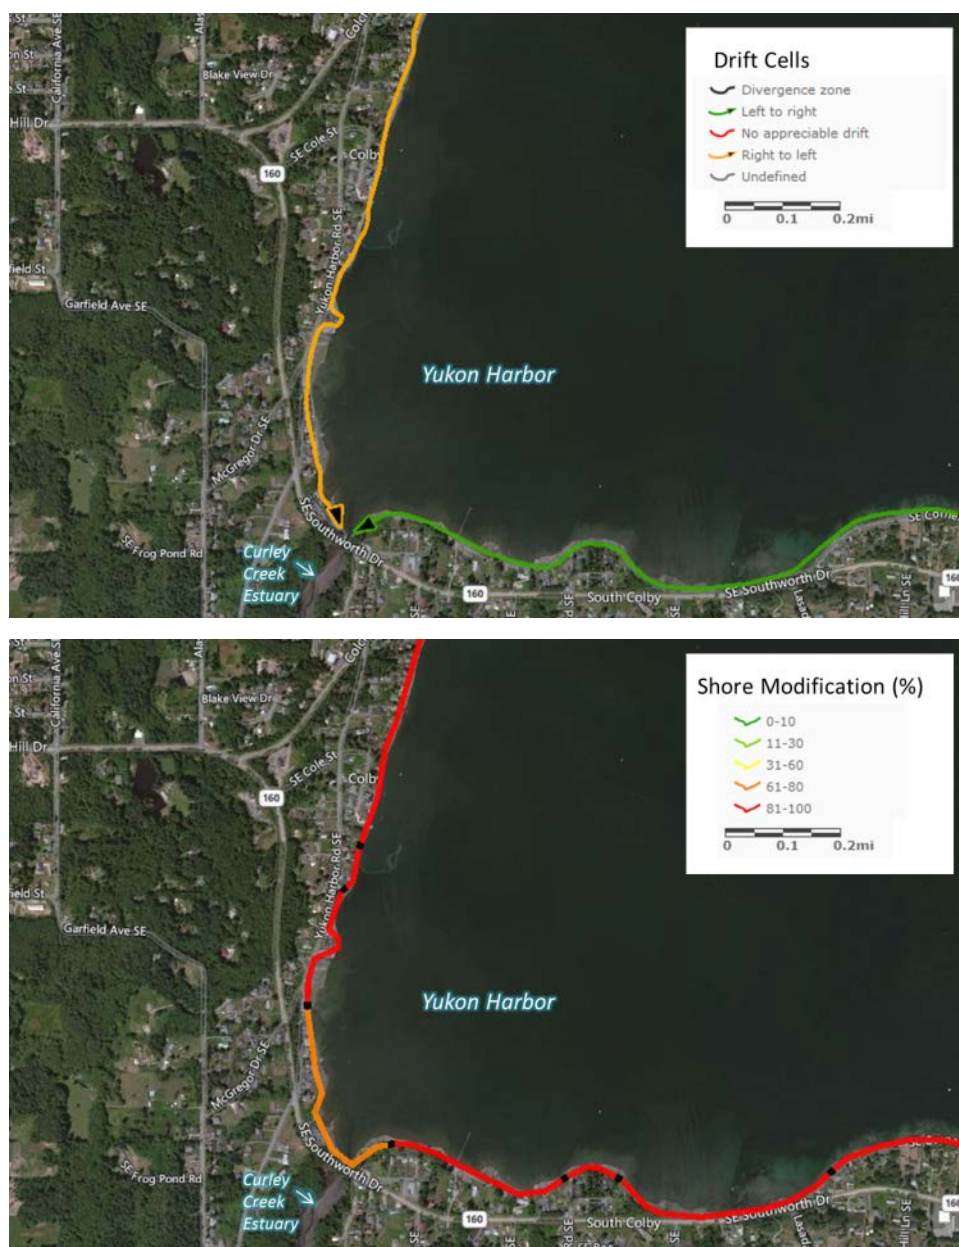
Figure 3-10. Drift cells and percentage of shore modification. Source: Washington State Department of Natural Resources (2000) ShoreZone Inventory.

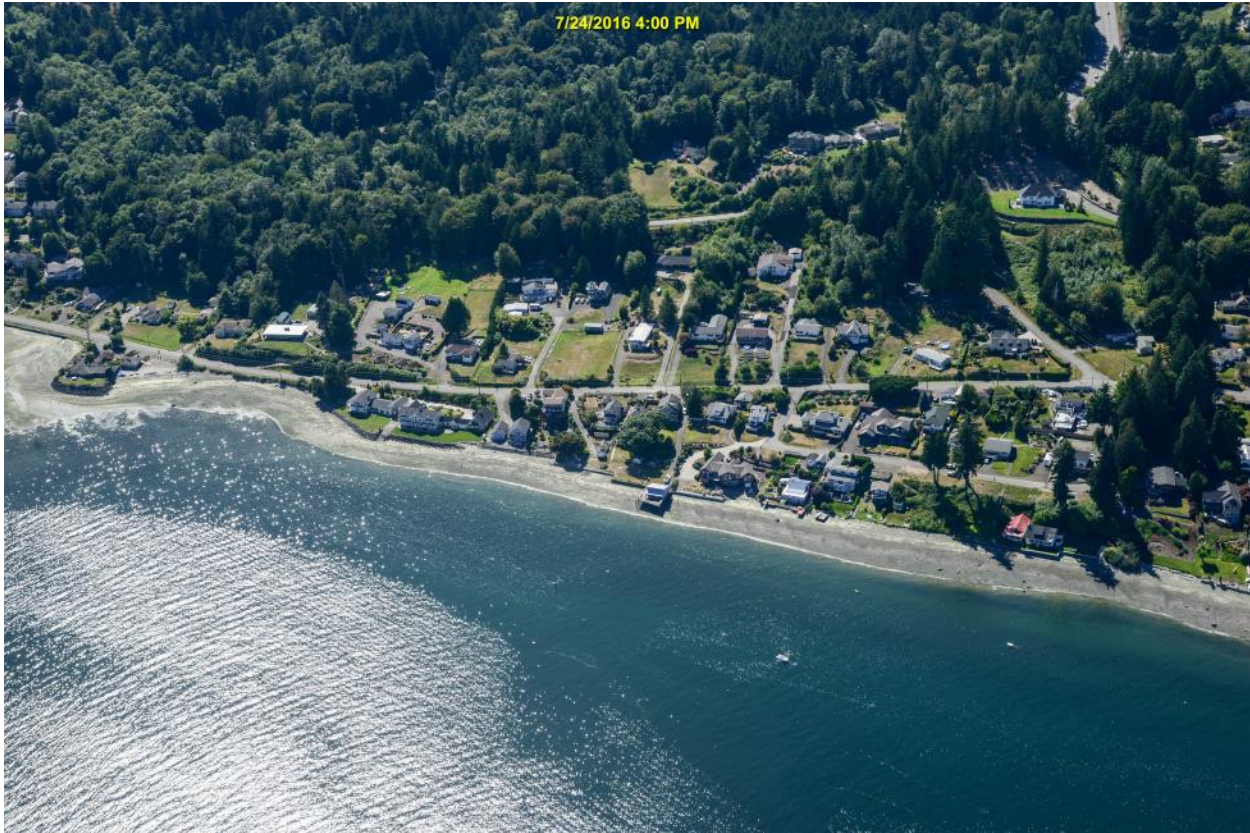
Figure 3-11. Photo of residential development and shoreline armoring in Yukon Harbor nearshore along drift cell to the northwest of the Curley Creek Estuary.

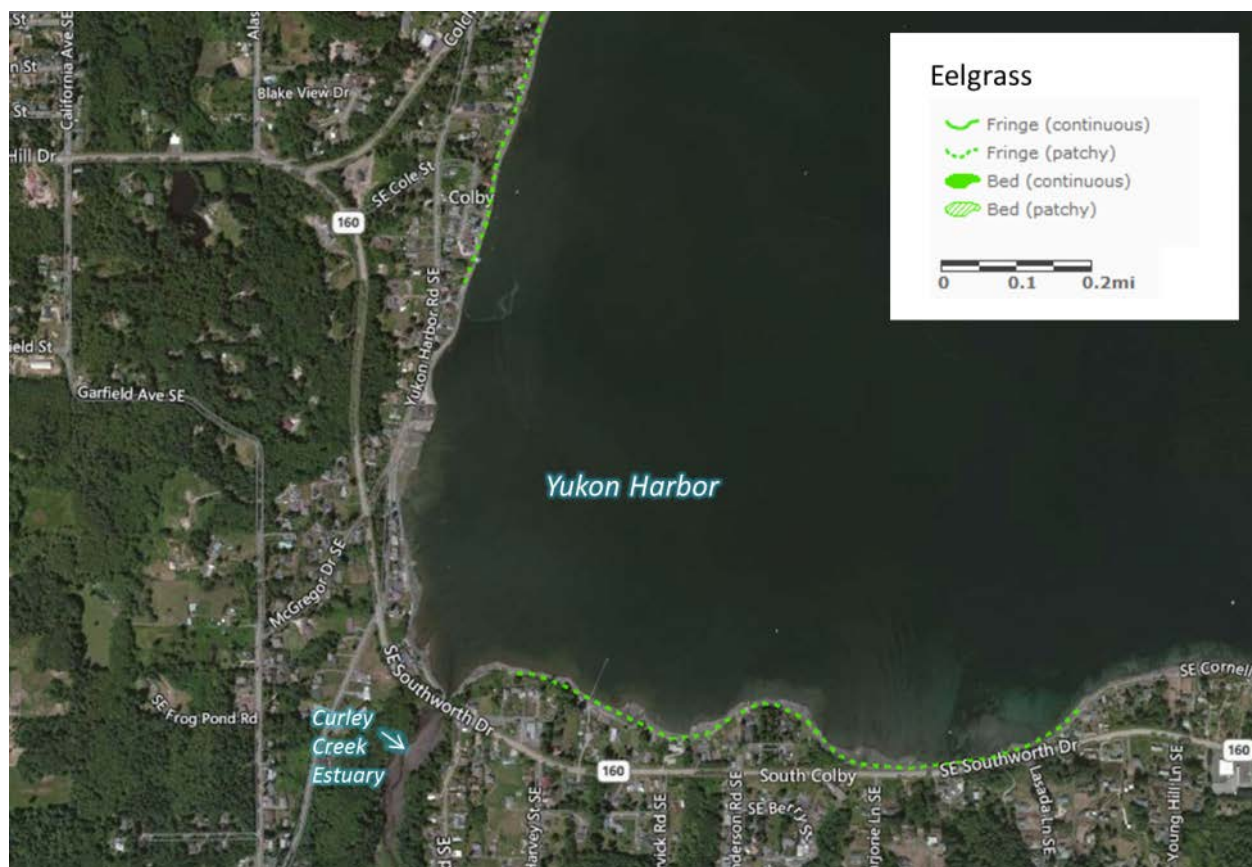
Figure 3-12. Eelgrass abundance in the Yukon Harbor nearshore. Source: Washington State Department of Natural Resources (2000) ShoreZone Inventory.

Submerged aquatic vegetation provide important habitat for crabs, scallops, fish, and other wildlife. The extent of eelgrass (*Zostera marina*) beds in Yukon Harbor is used as an indicator to monitor status of this KEA. The WDNR ShoreZone inventory (based on data from the 1990s) does not show any eelgrass beds in Yukon Harbor, nor fringe of eelgrass near the Curley Creek Estuary. The shoreline to the east of the Curley Creek Estuary and beginning approximately 0.5 miles north of the Estuary are mapped as having a patchy fringe of eelgrass (Figure 3-13). This shoreline was sampled by WDNR (Suquamish funded) in 2016-2017. Results are forthcoming.

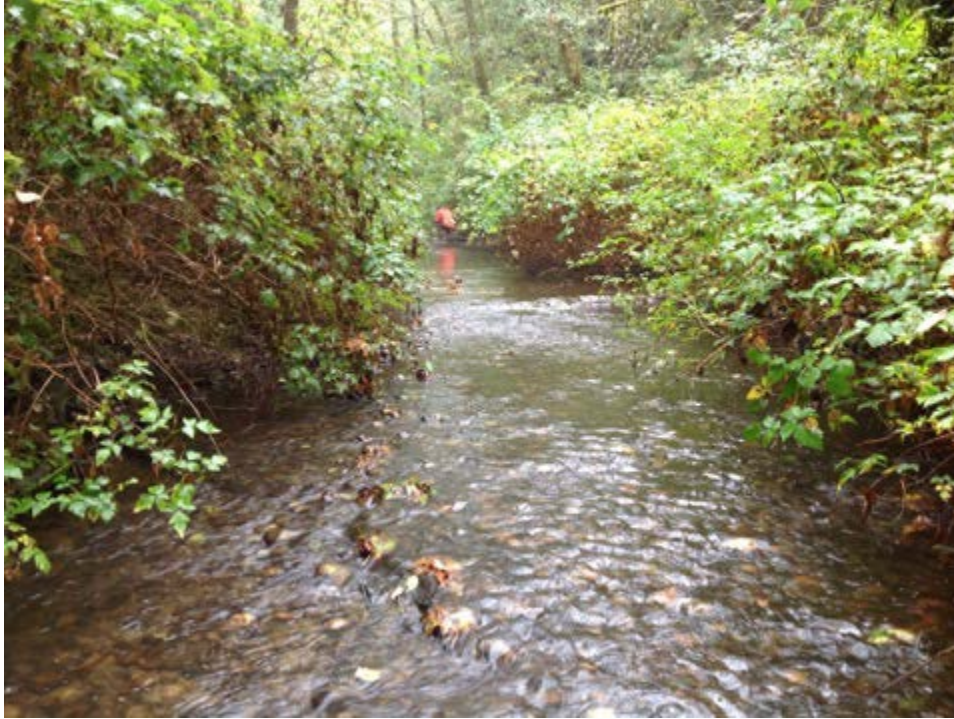
Figure 6-1. Photo of Curley Creek in ravine near junction of Mayvolt Road and Locker Road. The relatively low amount of large wood in the channel results in lack of channel complexity and low diversity of habitat types. Wood placement and protection of wood recruited to the channel will result in more frequent and deeper pool habitats, improved cover, and greater abundance of side channel habitat.

The stream corridor upstream of the Curley Creek Estuary is relatively confined by steep hillslopes forming a ravine. The corridor is recovering from past timber harvest and is currently well forested. A few limited exceptions include areas where residential properties have cleared trees along short segments of the stream corridor. The primary strategy recommended in this segment is protecting the stream corridor from land use impacts by establishing conservation easements along the channel and riparian corridor. There are also opportunities in some locations to restore native riparian vegetation where it has been removed or disturbed. In addition to protecting and restoring riparian processes, wood placement is recommended to increase channel complexity and provide a greater diversity of habitat types. Field reconnaissance of this segment shows a relatively low abundance of large wood in the channel despite the adjacent forest cover (Figure 6-1). Much of the wood recruited to the channel is deciduous species such as alder and maple that decay rapidly and are often too small to function as stable key pieces. Further, intentional wood removal from the channel by adjacent property owners limits wood abundance through parts of this segment. Given this segment has stretches with recovering riparian forest conditions that may yield good potential for wood-recruitment as the forest matures, wood placement actions should be focused on segments where riparian impacts are greatest and natural wood recruitment is unlikely to occur in the foreseeable future.

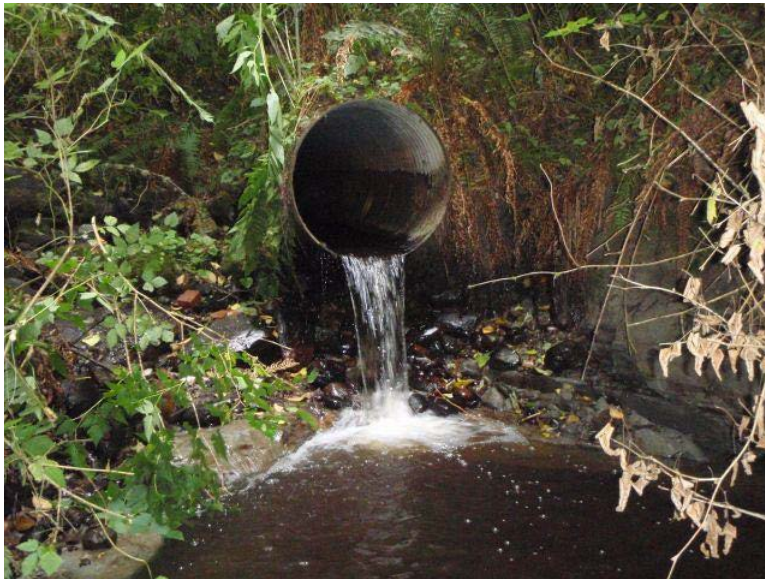
Figure 6-4. Culvert in Banner Creek (15.0186) at Sedgwick Road (photo from WDFW).

The perched outlet could indicate the effects of past incision in the reach. The undersized culvert acts as a grade control and this rigidity causes problems in a stream that may adjust vertically over time; an abrupt drop will develop at the outlet as the downstream channel degrades. A drop can also form when an undersized culvert prevents adequate passage of upstream sediment and wood, and from high velocities through the pipe. The potential consequences for renewed incision with further progression of a headcut through the upstream channel segment should be considered. In addition to culvert replacement, the channel may also need to have wood placed in both the downstream and upstream segments to re-establish channel complexity, promote sediment storage, and prevent additional accelerated incision.

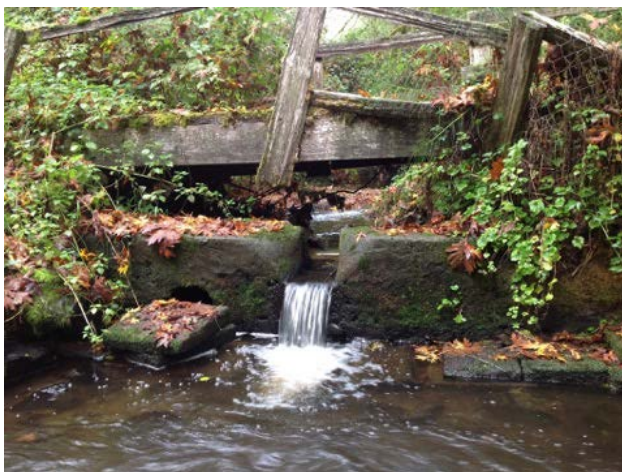
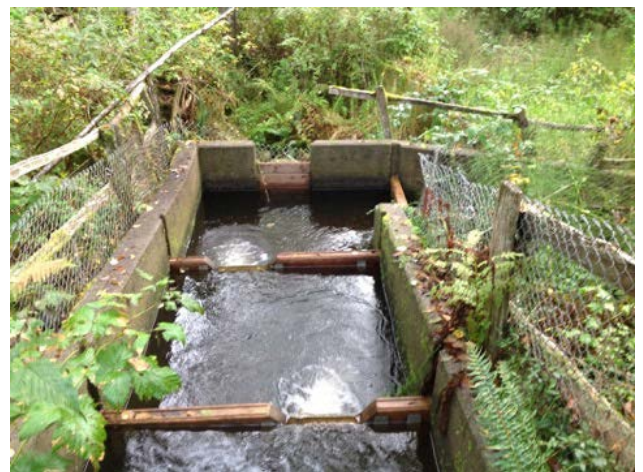
Figure 6-5. Photos of the fishway in Unnamed Tributary 15.0187.

In the near term, recommended actions in this area include a simple replacement of the concrete control with additional weirs or log assemblage that reduce the water surface drop to enhance fish passage. Recommendations for longer term actions at this site include removal of the dam and restoration of floodplain and channel migration zone connectivity at the tributary confluence. Such actions will require dedicating a stream corridor and creating a new channel through or around the existing upstream impoundment. Riparian vegetation should be planted to provide forest cover along the stream and wood placements in this restored stream corridor will be important to maintain channel complexity over future decades until the riparian forest can mature to a point where natural rates of wood recruitment can be restored.

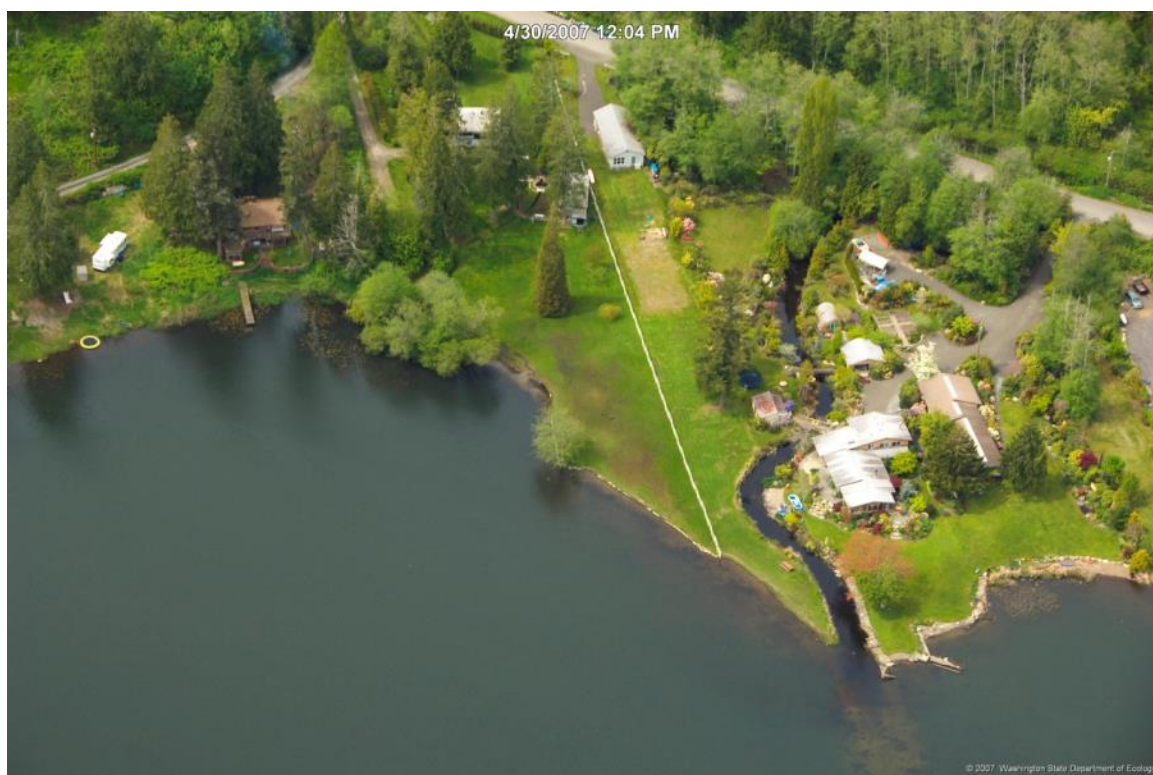
Figure 6-6. Mouth of Salmonberry Creek where it flows into Long Lake (2007 photo from Department of Ecology Shoreline Atlas).

The Salmonberry Creek mouth where it flows into Long Lake is an important transition zone for both adult salmon migrating upstream and juvenile salmon either outmigrating or seeking rearing habitat near the lakeshore. The existing outlet channel crosses three residential properties downstream of Clover Valley Road and has minimal riparian cover along the approximately 500 foot long segment upstream of the lake (Figure 6-6).

Restoration actions recommended in this area include removing constraints to lateral channel migration and planting in the riparian corridor. Actions are constrained by the current land use. Replanting the riparian corridor could be feasible through coordination with existing landowners. Smaller wood placements may be possible without adverse impacts to private property. Full restoration of natural processes in this segment would include larger wood placements that exert geomorphic responses and reconnect the floodplain and channel migration zone. Such actions may not be compatible with existing land use but should be considered a long term objective requiring potential easements or acquisition should the properties be offered for sale at a future date.

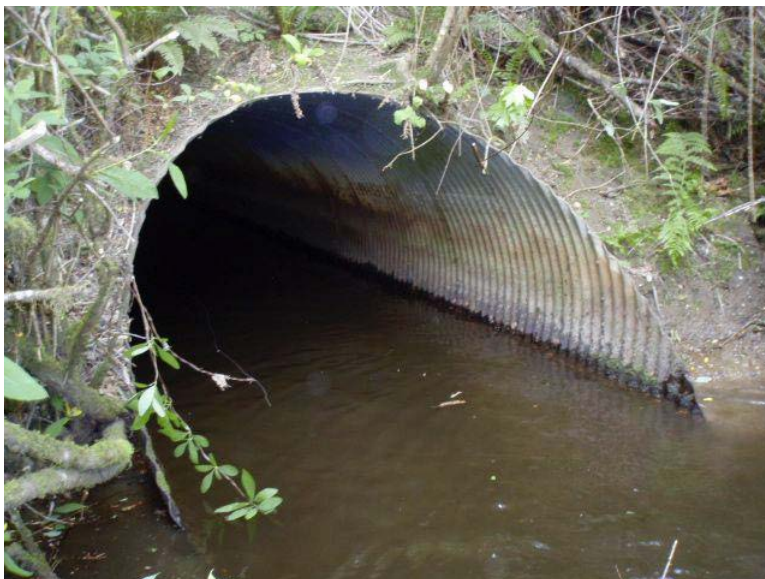
Figure 6-7. Existing culvert in Salmonberry Creek at SE Baker Road (photo from WDFW).

Salmonberry Creek flows through a 6 foot diameter round culvert at a slope of 2.2% (Figure 6-7). Channel slope in the upstream and downstream channel segments is less than 0.5%. WDFW's Level A culvert assessment lists the crossing as a fish passage barrier given that the culvert slope exceeds 1%. During field reconnaissance in 2015 with Suquamish Tribe Fisheries staff, the crossing at Baker Road was observed to be backwatered such that slope of the culvert was not creating a fish passage barrier at that time. The cause of the backwater effect was not determined but may have been associated with beaver activity in the downstream channel segment. The recommendation is to replace the existing culvert with a bridge or larger culvert that meets design criteria in the WDFW water crossing guidelines.

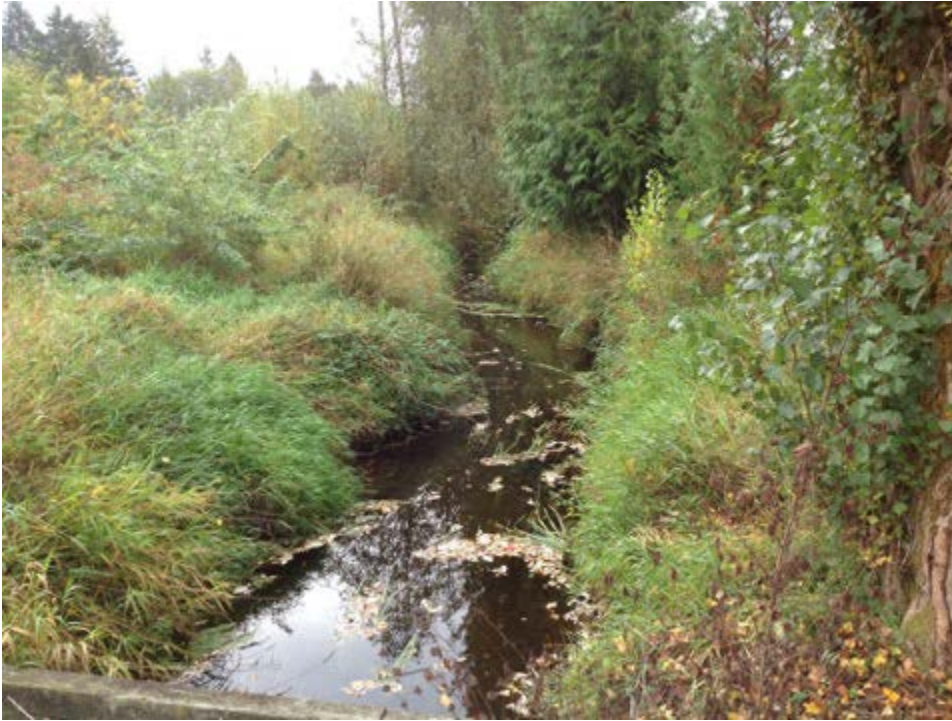
Figure 6-9. Channelized segment of Salmonberry Creek downstream of Sedgwick Road.

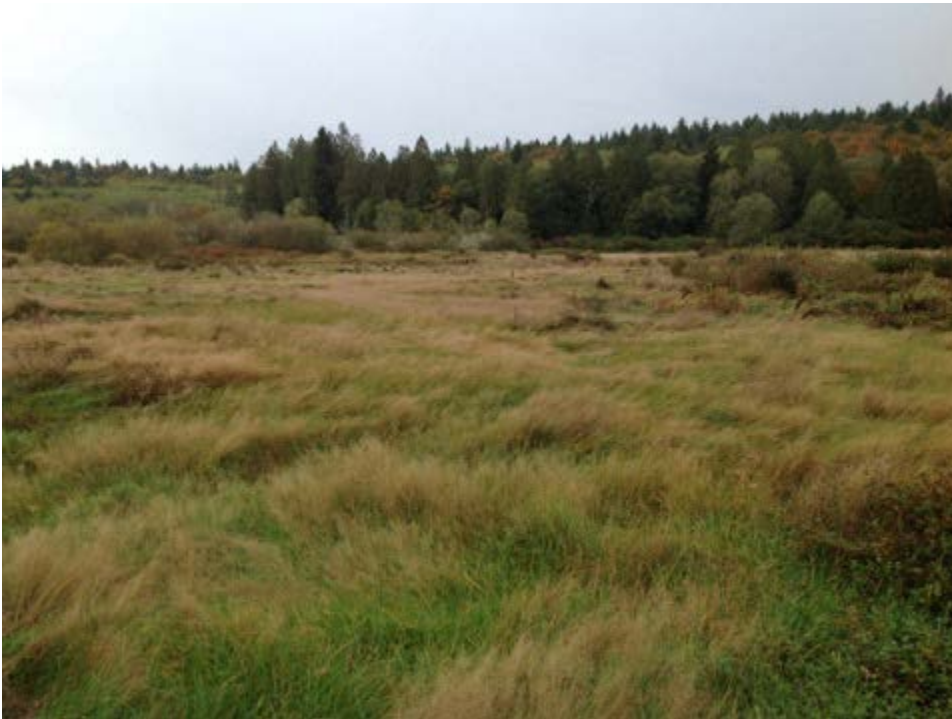
Figure 6-10. Disconnected floodplain area adjacent to ditch shown in photo above.

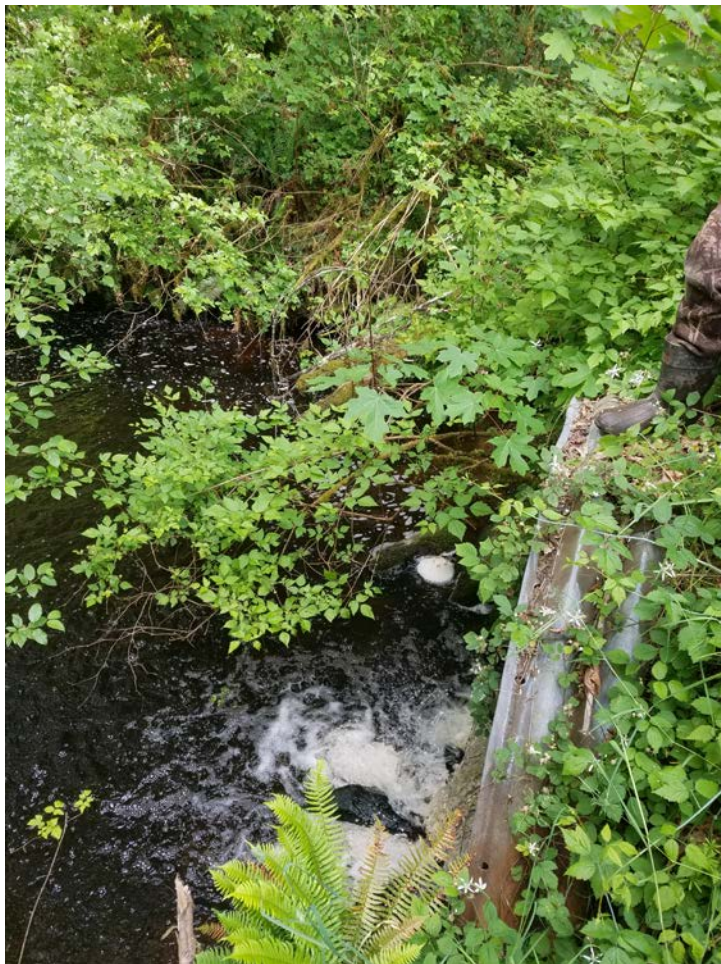
Figure 6-11. Culvert in Salmonberry Creek at Sedgwick Road (photo from Steve Todd).

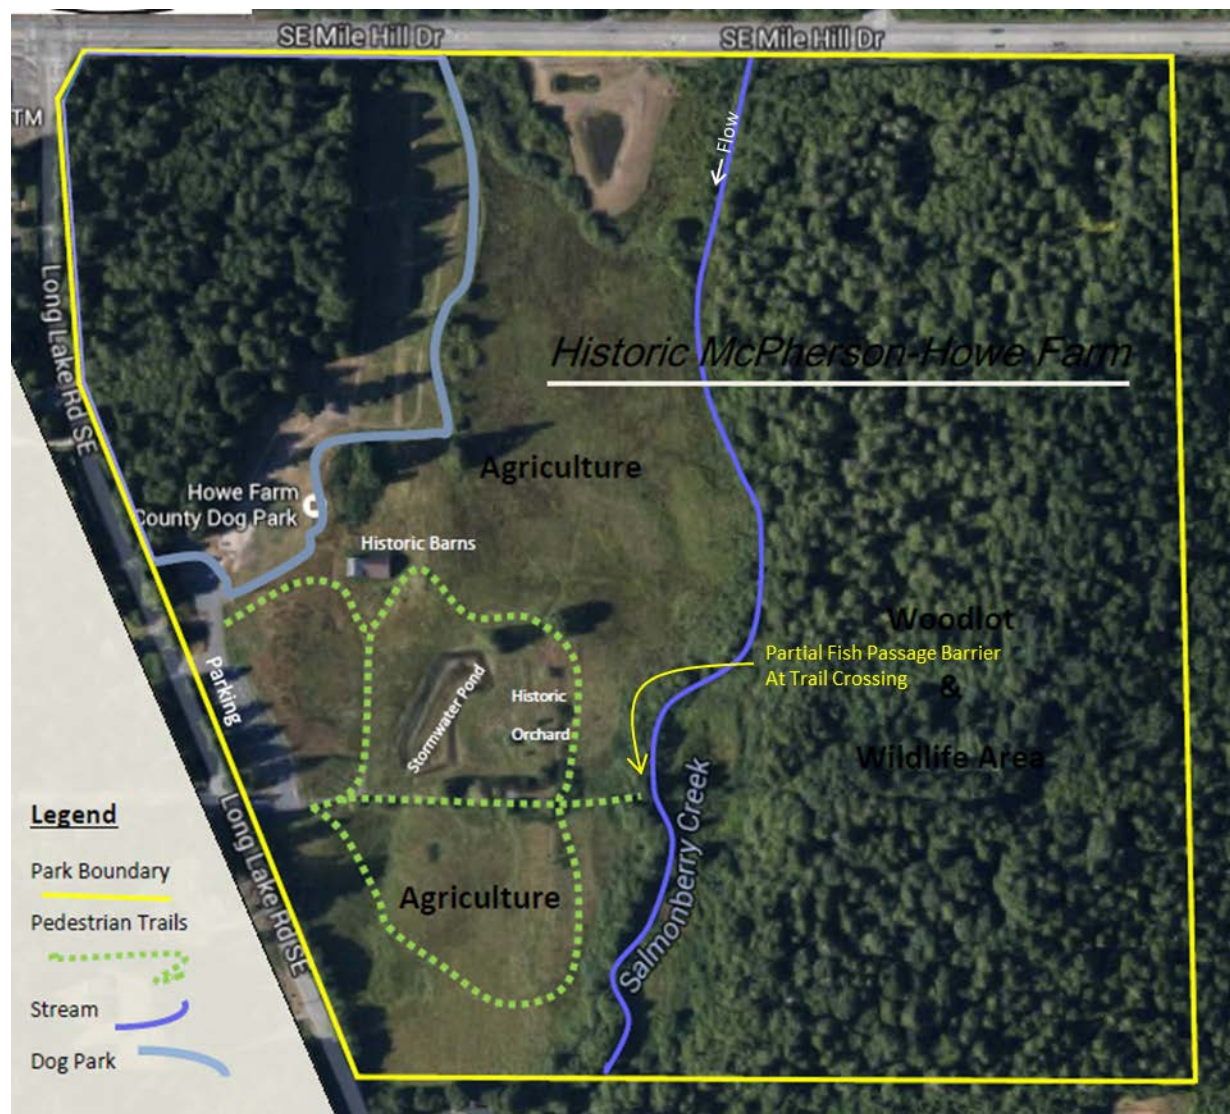
Figure 6-14. Map of Howe Farm County Park. (Source: Kitsap County Parks).

Kitsap County purchased the farm located between Long Lake Road and Mile Hill Road in 1996 to establish a preserved farmland park. There is an approximately 1,000 foot long segment of the stream near the middle of the property that has a very narrow riparian corridor (Figure 6-14). Willow plantings were established along the stream in the 1990s and conifers in more recent years but there are opportunities to expand and enhance the riparian vegetation as well as install wood structures throughout the stream corridor at Howe Farm. Field reconnaissance in spring 2017 observed evidence of beaver in the reach upstream of the fish barrier culvert crossing, including open water areas (Steve Todd, Suquamish Tribe Fisheries Department).

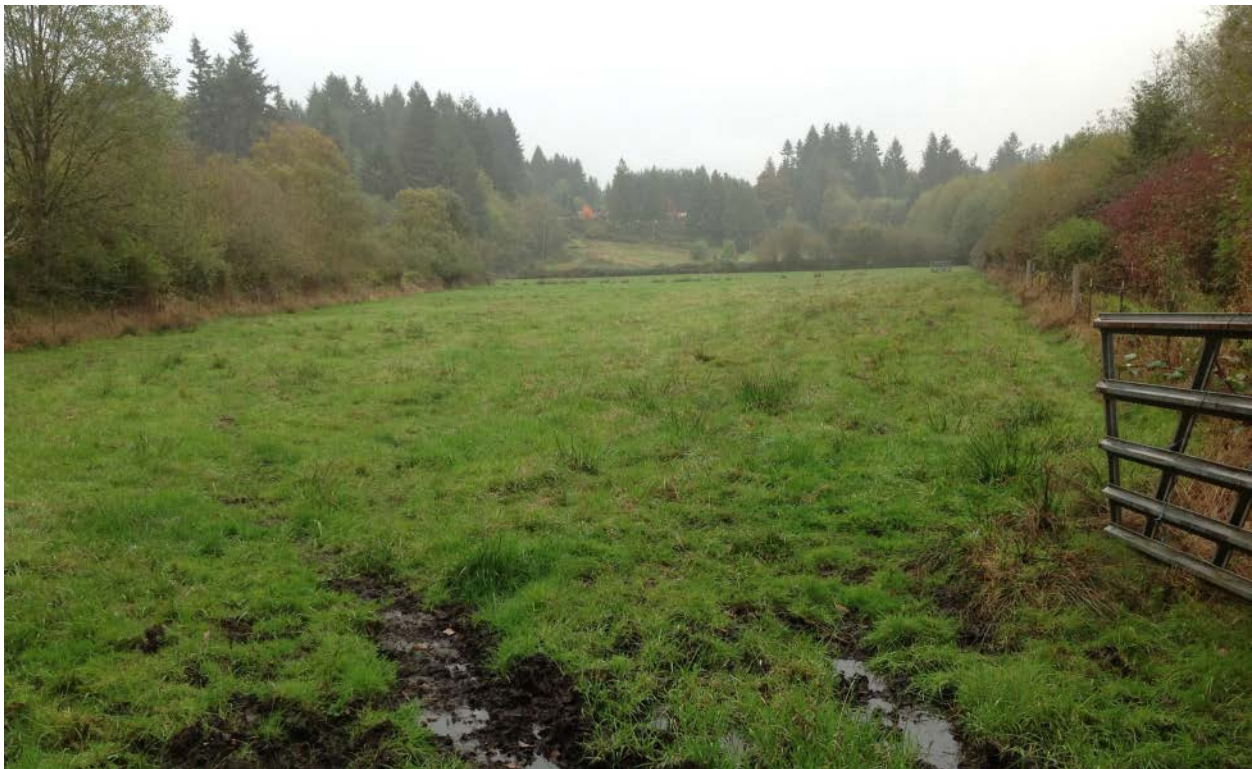
Figure 6-16. Photo of the Cool Creek floodplain at Ashby Farm (view upstream). Cool Creek is channelized within a narrow corridor at the right side of the image.

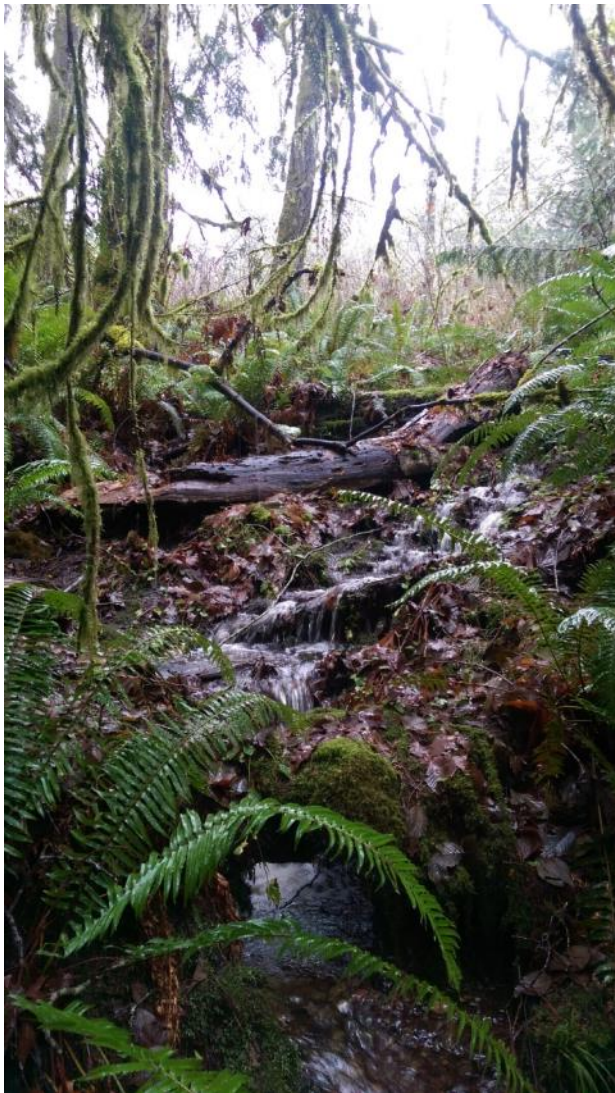
Figure 6-17. Small tributary to Cool Creek that conveys runoff from development in the Port Orchard UGA (Photo by Steve Todd, Suquamish Tribe).

tributary that joins Cool Creek only a few hundred feet upstream of Phillips Road is not included on the WDNR water type map. This tributary has physical characteristics that would support salmonids; however, the channel appears more incised as it nears an area that is currently undergoing residential development. At least two additional tributaries that are also not shown on water type maps join this left bank tributary to Cool Creek (Figure 6-17). These tributaries may provide habitat for coho, cutthroat, and steelhead, and they are important source areas for runoff and sediment that are sensitive to channel incision given the steep gradient and proximity to residential developments.

Recommended actions include detailed mapping of the tributary channels to identify their locations and geomorphic characteristics. Defining a riparian corridor around these channels is important for establishing protection from future disturbance and supporting the maturity of existing riparian vegetation. Wood placement in these tributaries will be important for maintaining hydraulic resistance and preventing further channel incision that would result in excessive sedimentation to downstream reaches.

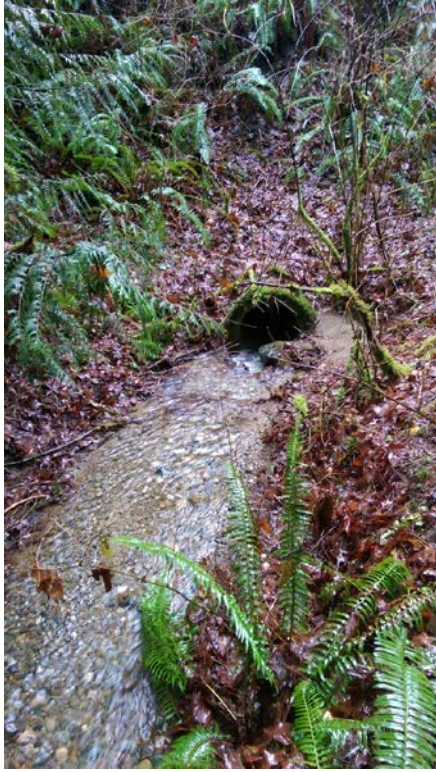
Figure 6-18. Culvert in Upper Curley Creek at Mullenix Road (Photo by Steve Todd, Suquamish Tribe).
